**This project update covers the period  
of March 2025**

### **A summary of the work carried out in the Month of March**

## Cyclops restoration programme March 2025

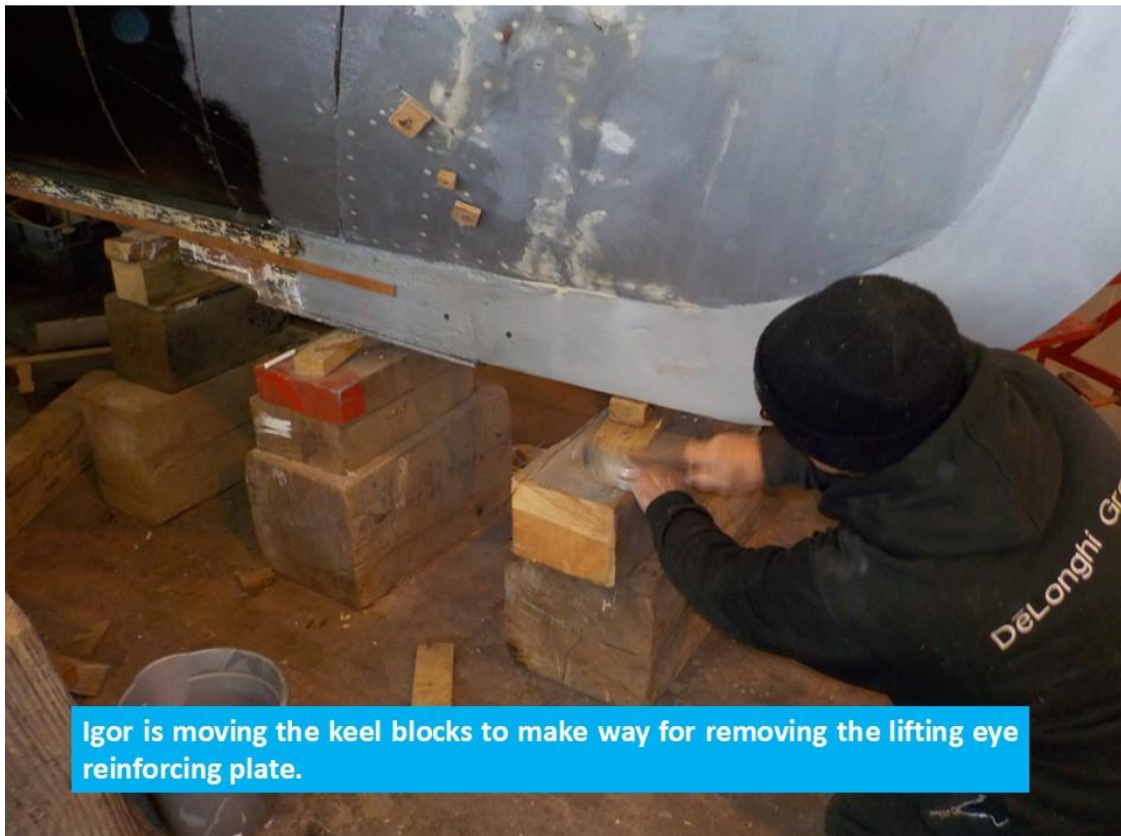
Igor is moving the keel blocks to make way for removing the lifting eye reinforcing plate.

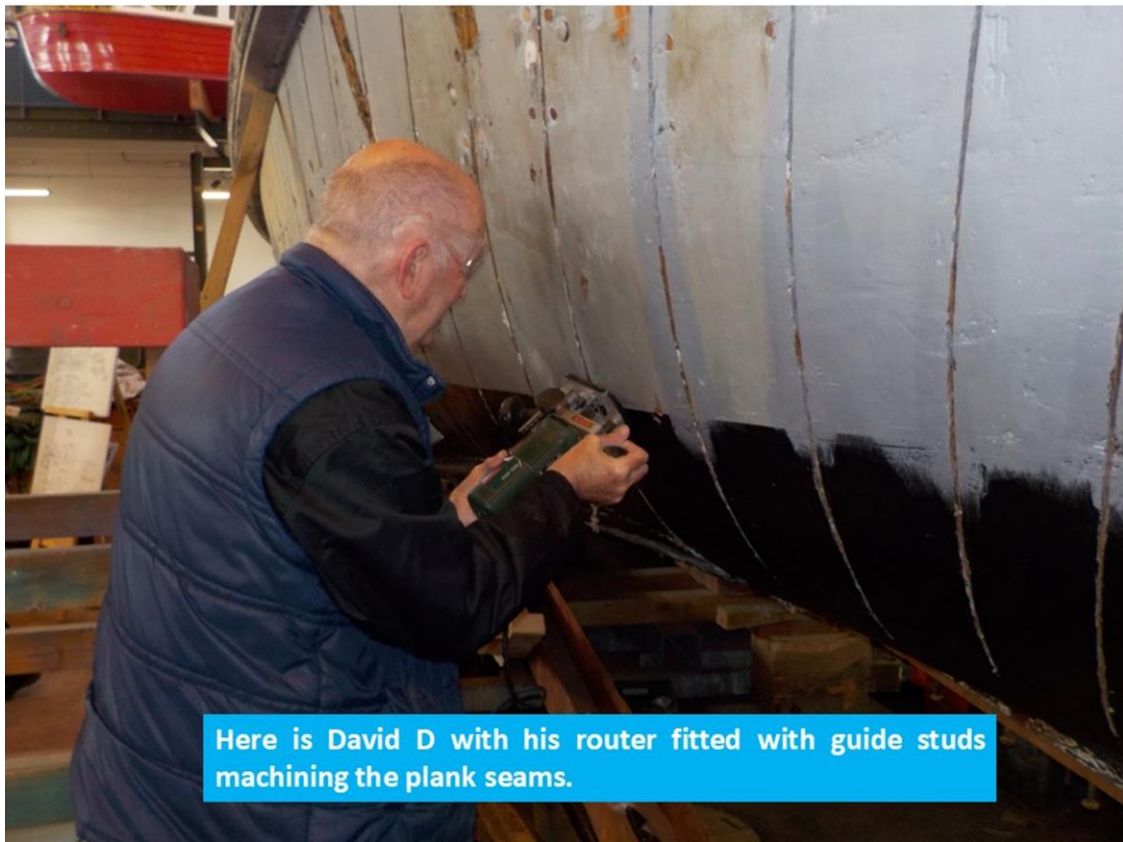
Here is David D with his router fitted with guide studs machining the plank seams.

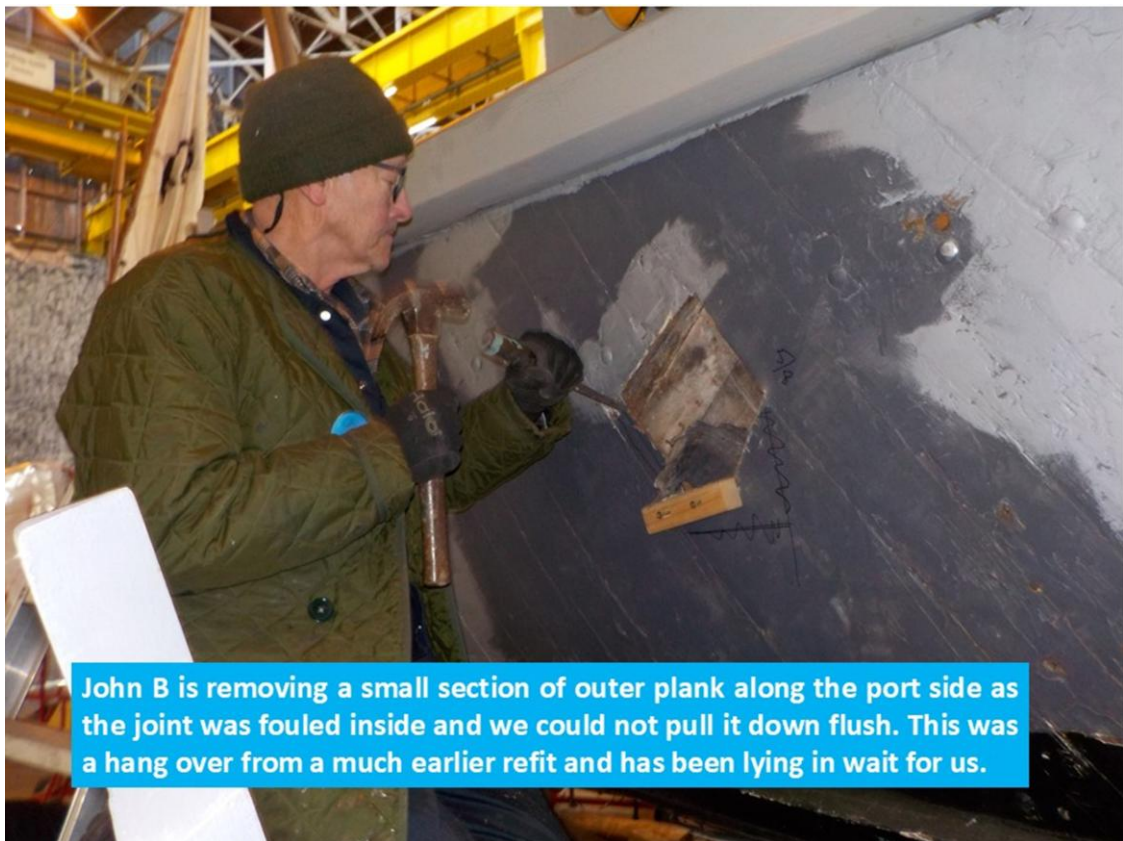
John B is removing a small section of outer plank along the port side as the joint was fouled inside and we could not pull it down flush. This was a hang over from a much earlier refit and has been lying in wait for us.

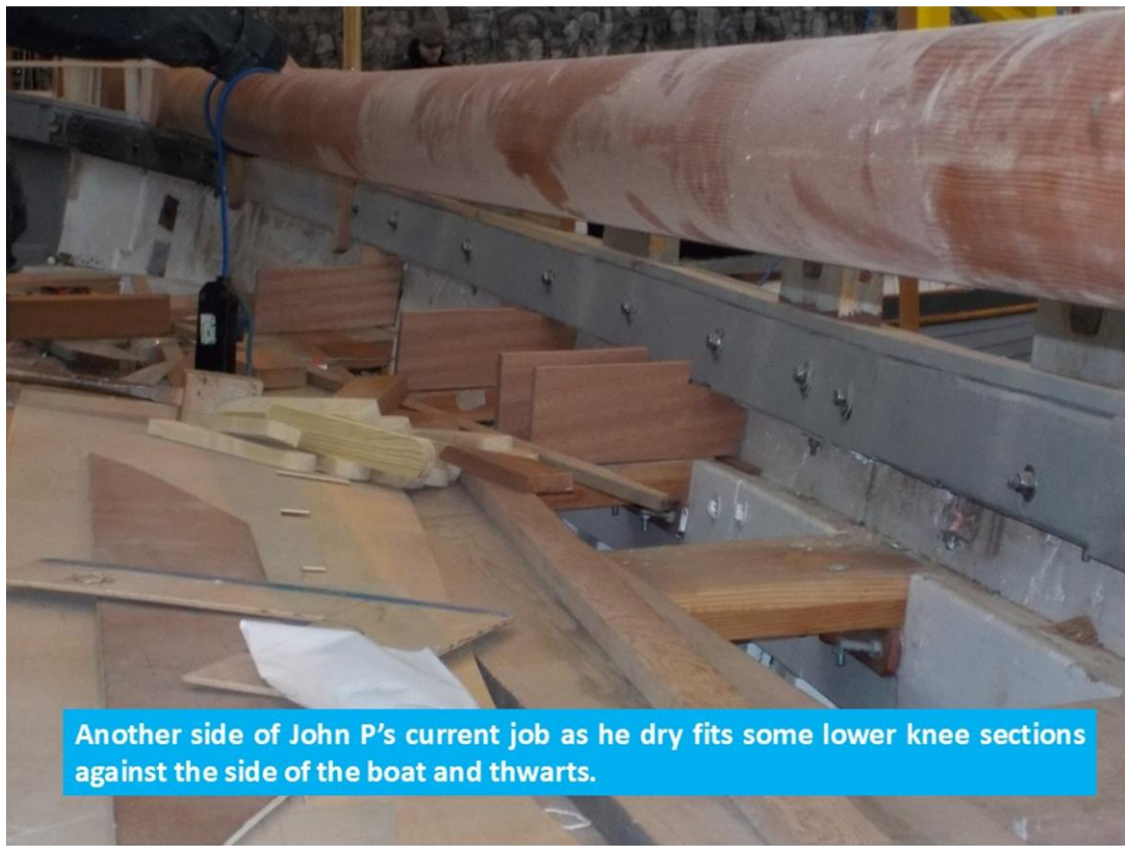
Another side of John P's current job as he dry fits some lower knee sections against the side of the boat and thwarts.

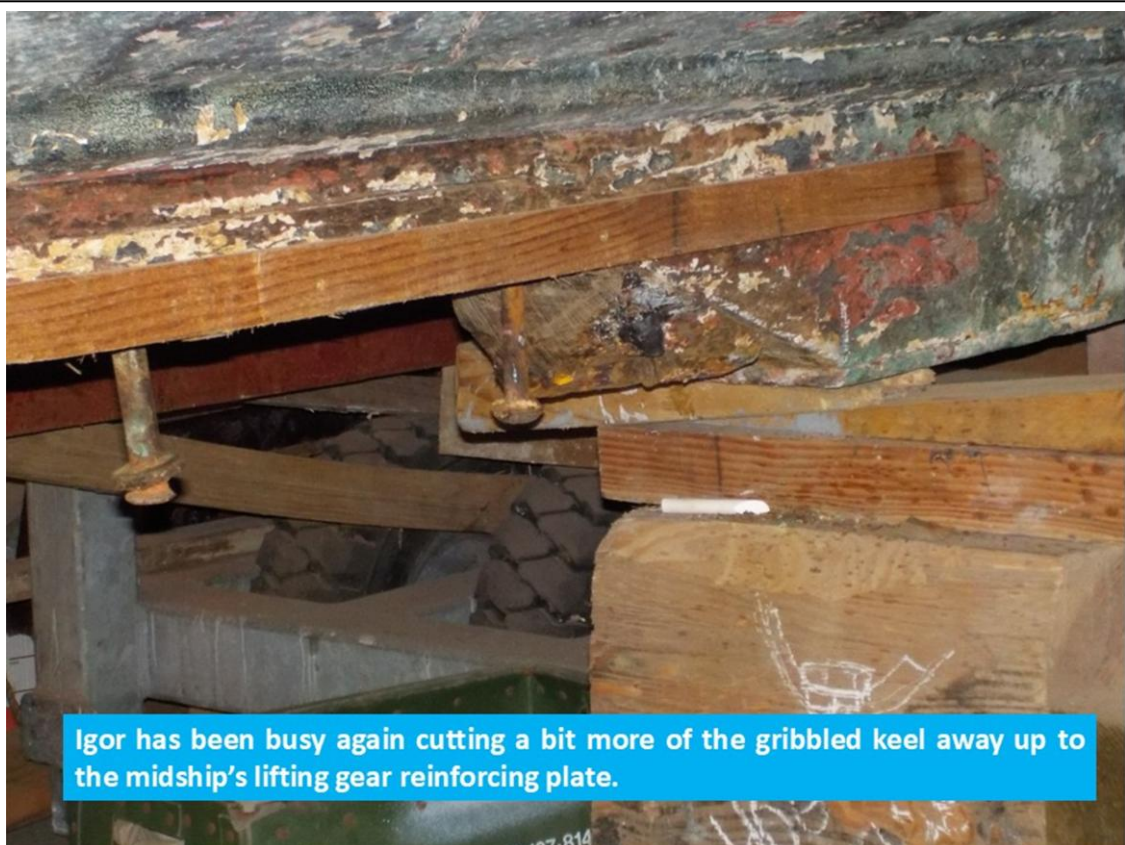
Igor has been busy again cutting a bit more of the gribbled keel away up to the midship's lifting gear reinforcing plate.

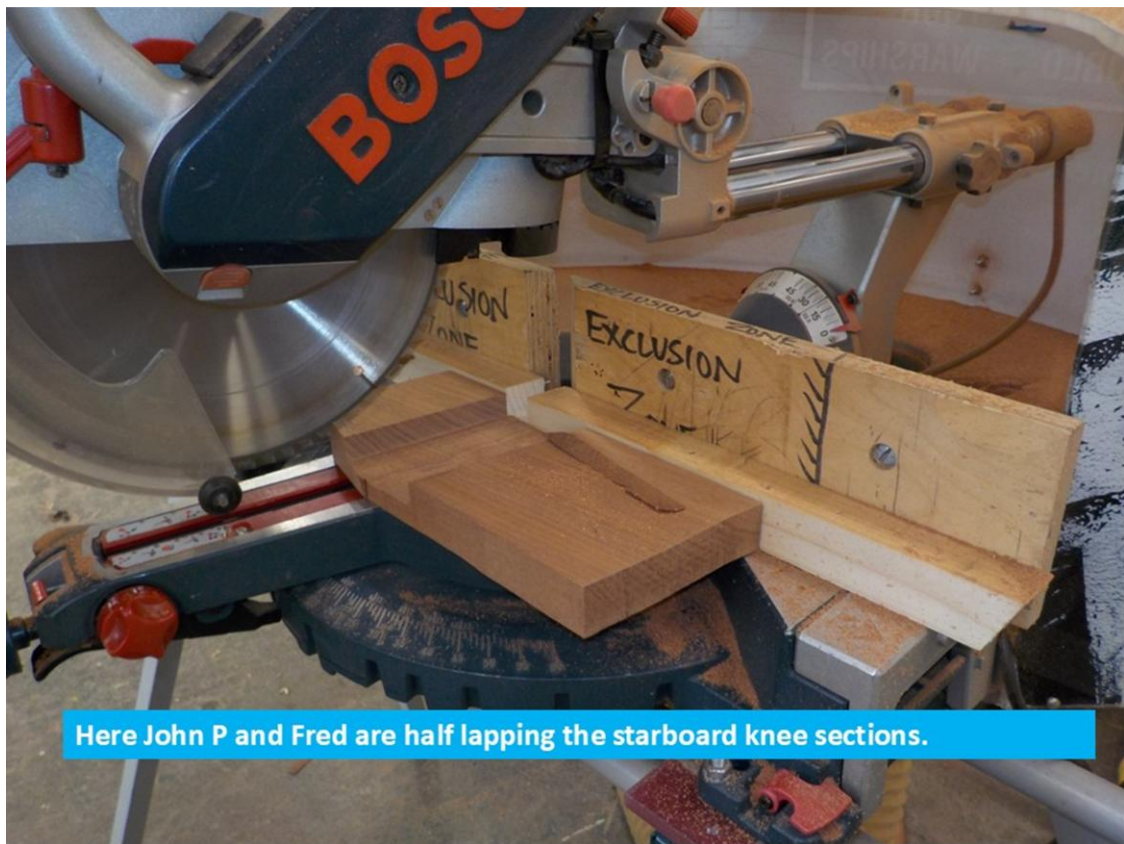
Here John P and Fred are half lapping the starboard knee sections.

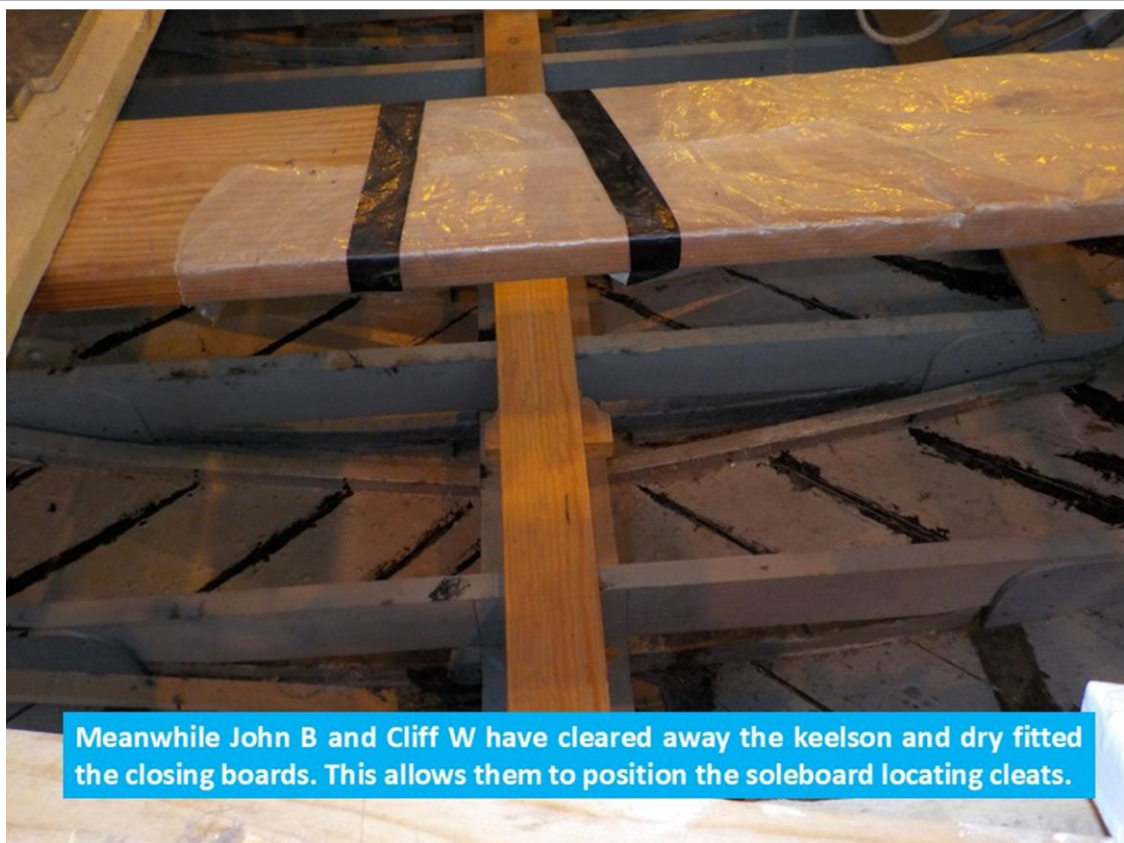
Meanwhile John B and Cliff W have cleared away the keelson and dry fitted the closing boards. This allows them to position the soleboard locating cleats.

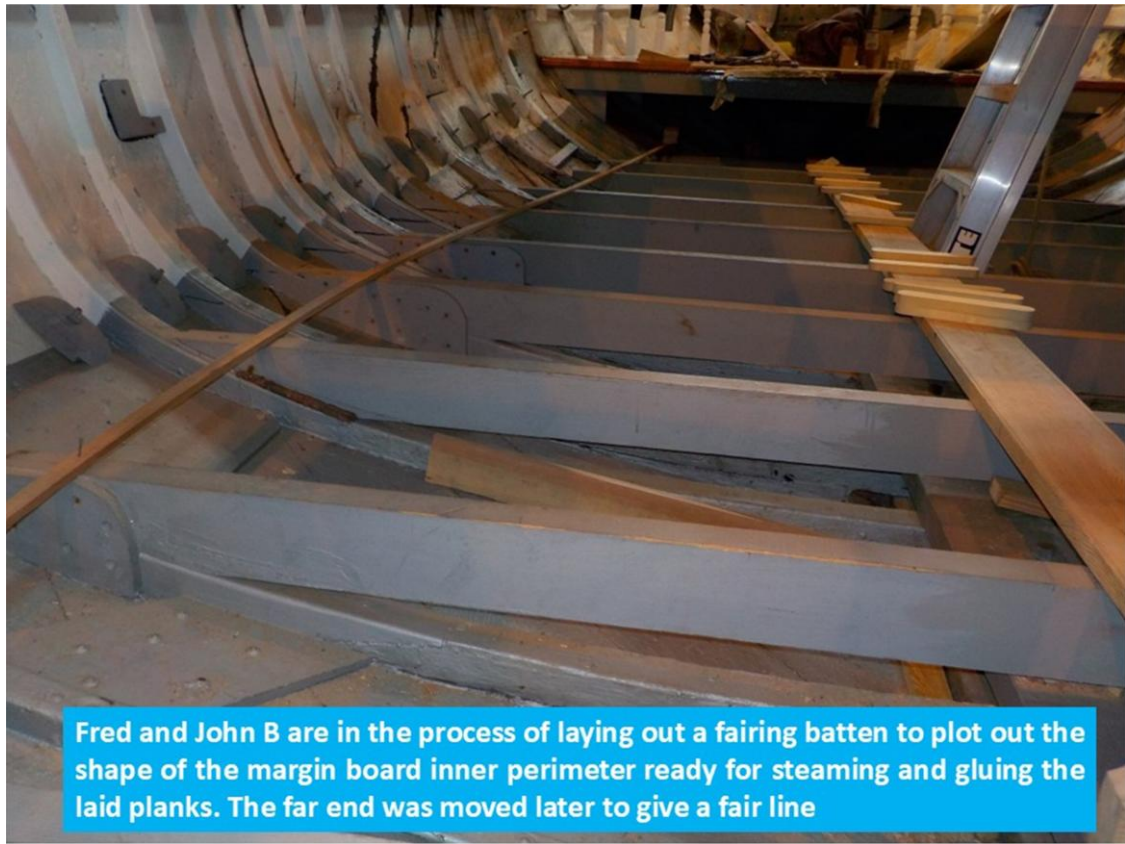
Fred and John B are in the process of laying out a fairing batten to plot out the shape of the margin board inner perimeter ready for steaming and gluing the laid planks. The far end was moved later to give a fair line

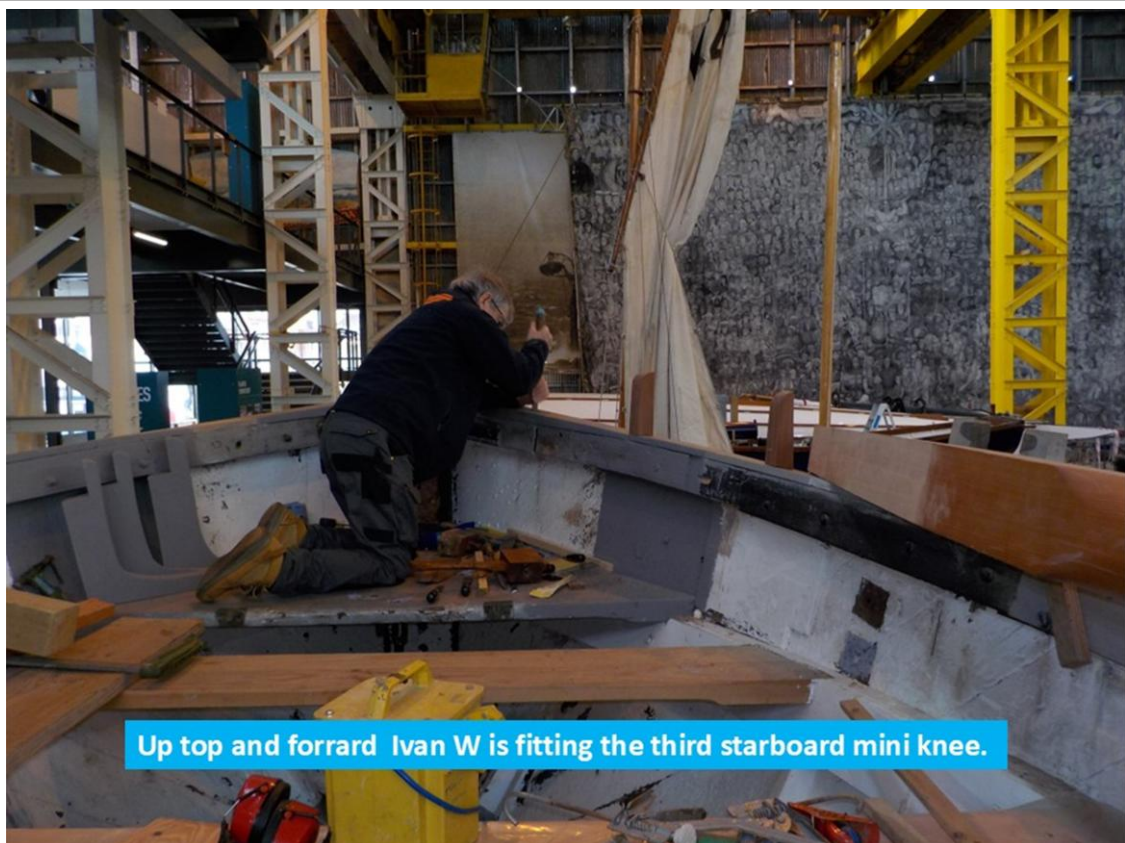
Up top and forrard Ivan W is fitting the third starboard mini knee.

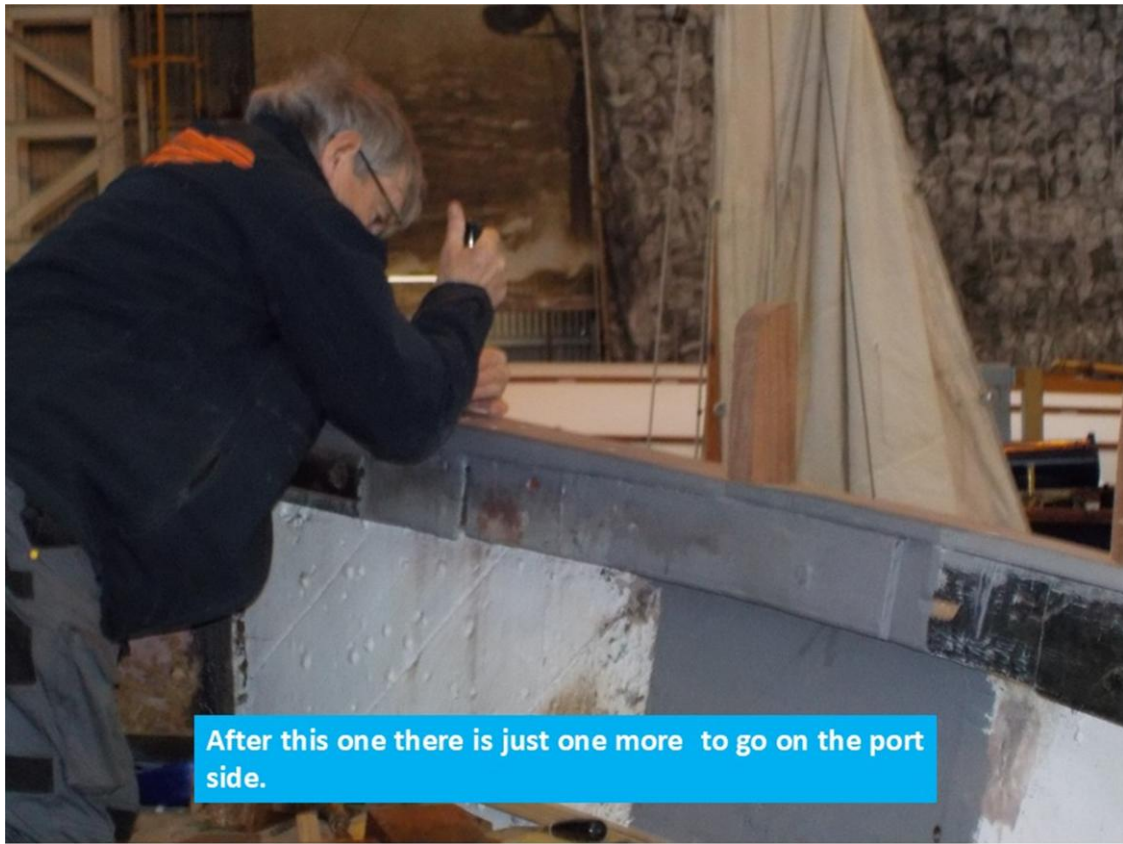
After this one there is just one more to go on the port side.

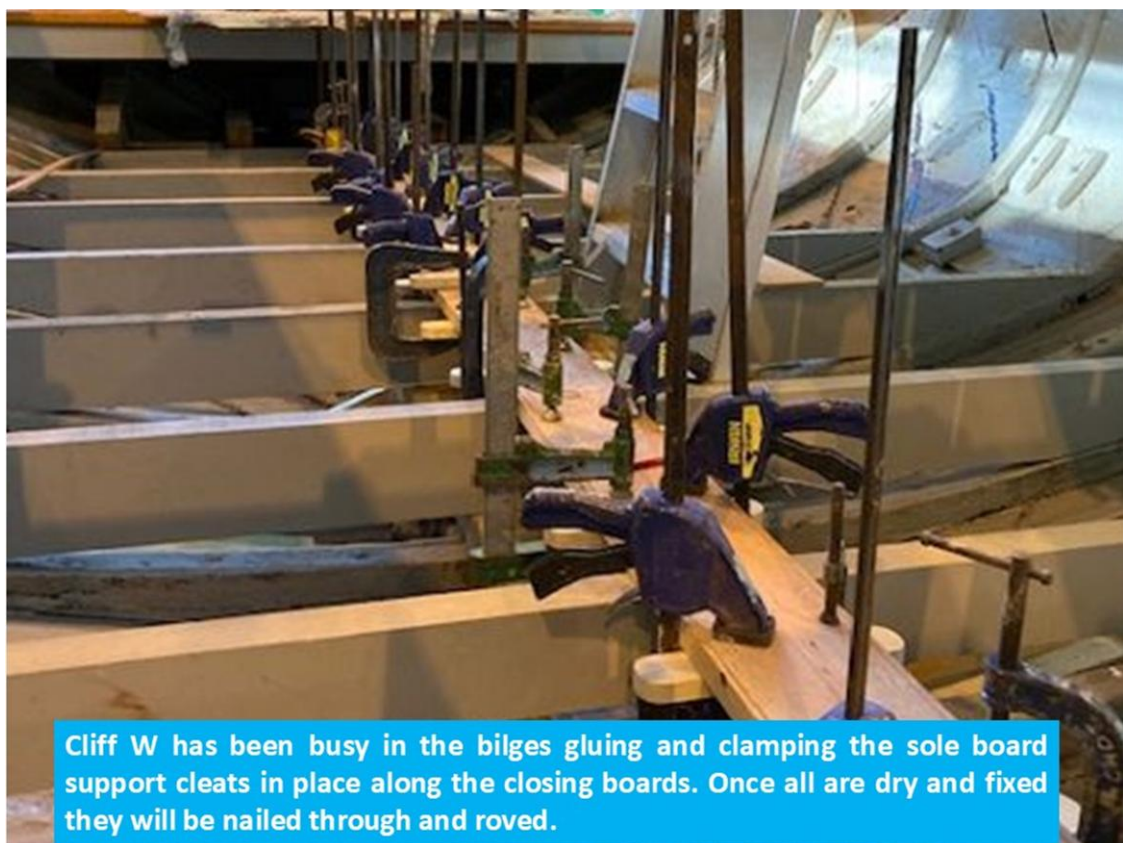
Cliff W has been busy in the bilges gluing and clamping the sole board support cleats in place along the closing boards. Once all are dry and fixed they will be nailed through and roved.

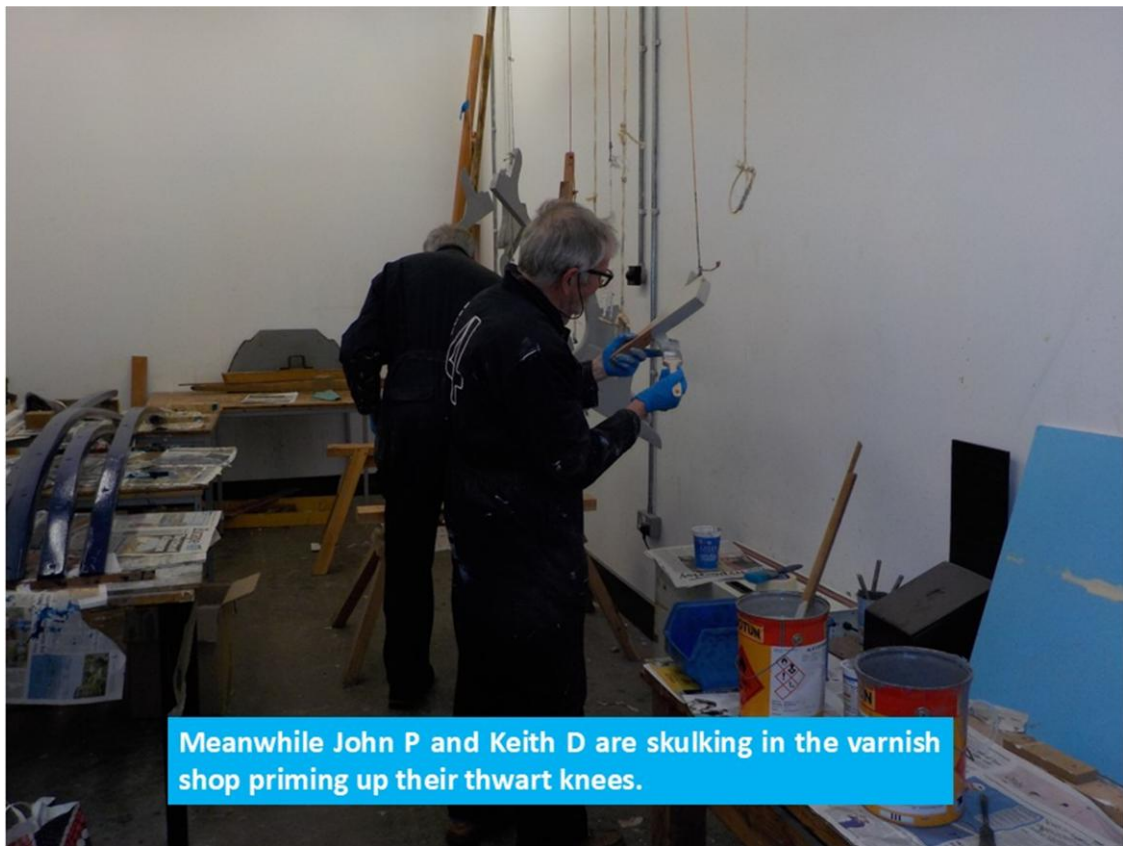
Meanwhile John P and Keith D are skulking in the varnish shop priming up their thwart knees.

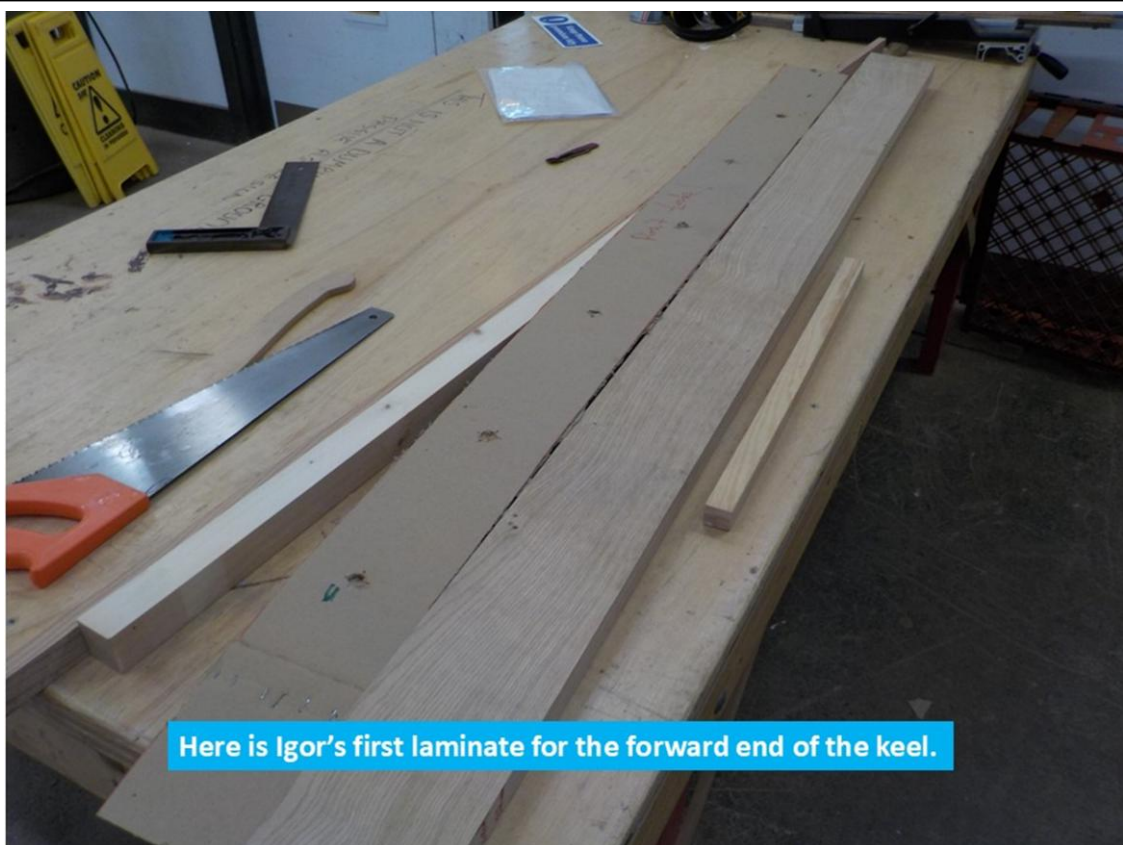
Here is Igor's first laminate for the forward end of the keel.
