**This project update covers the period
of June 2025**

A summary of the work carried out in the Month of May

Cyclops restoration programme June 2025

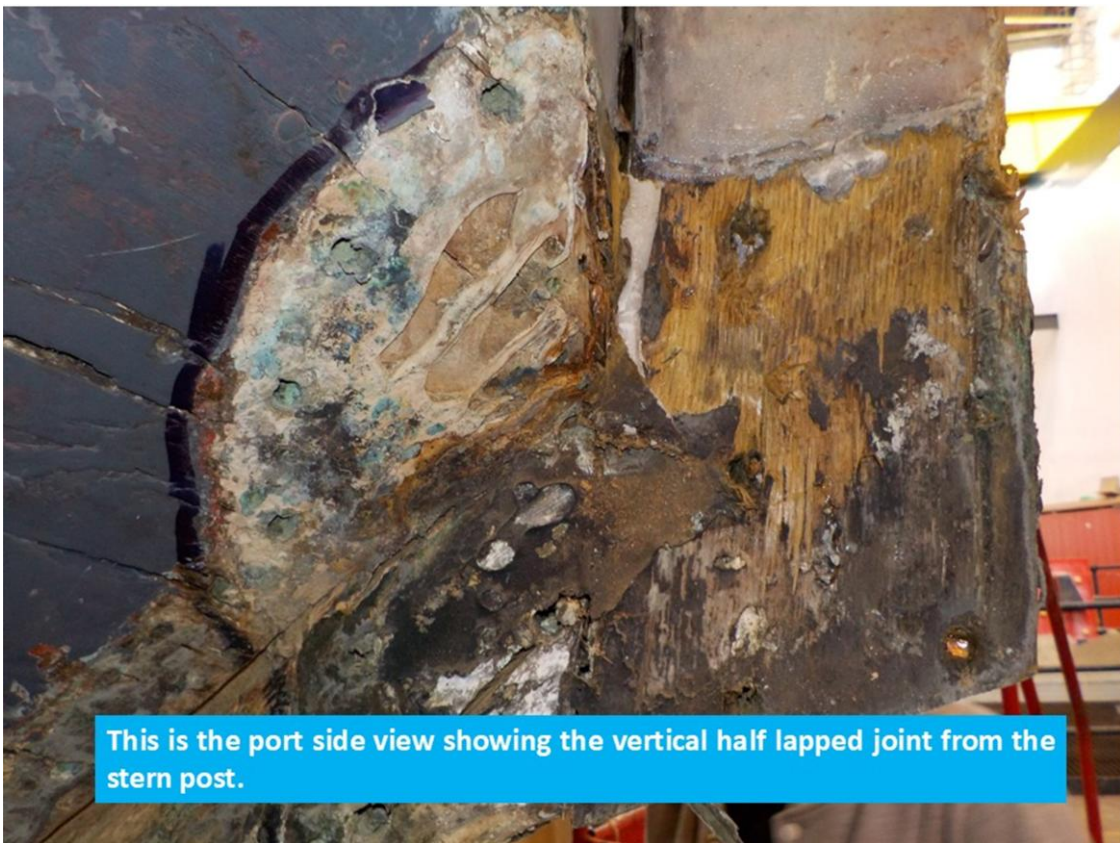
This is the port side view showing the vertical half lapped joint from the stern post.

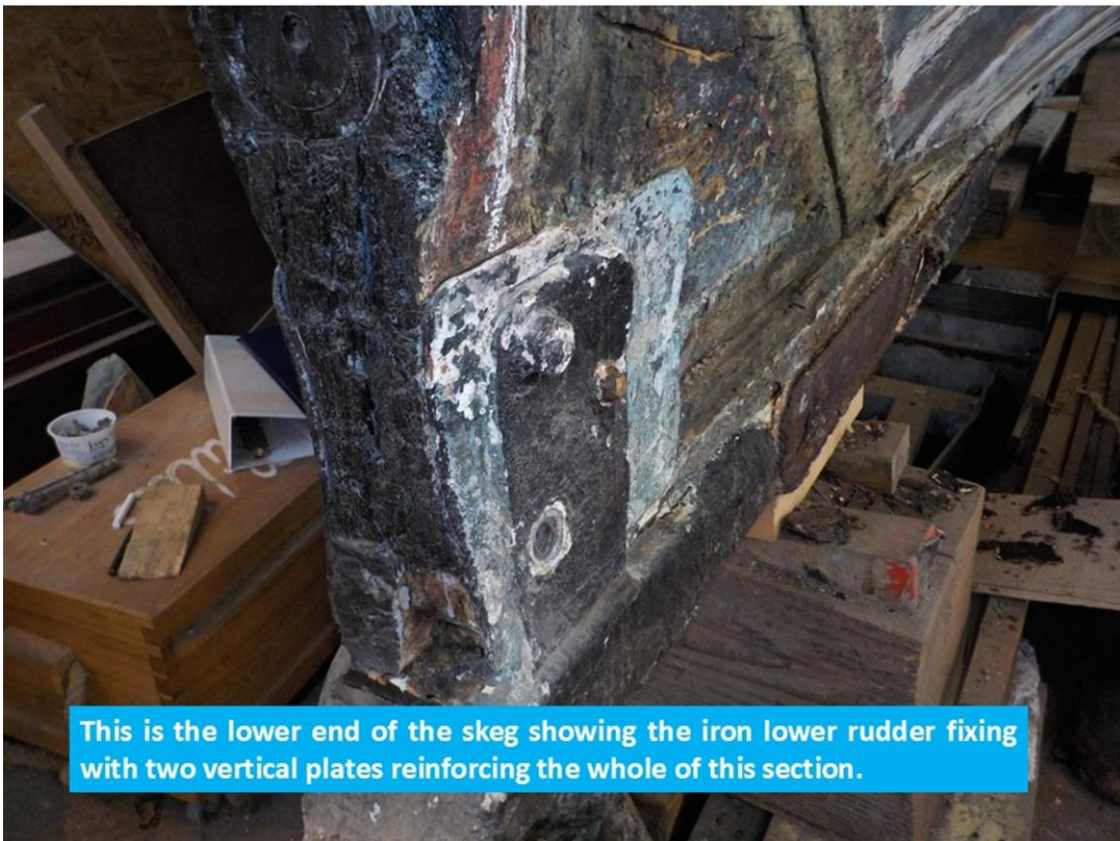
This is the lower end of the skag showing the iron lower rudder fixing with two vertical plates reinforcing the whole of this section.

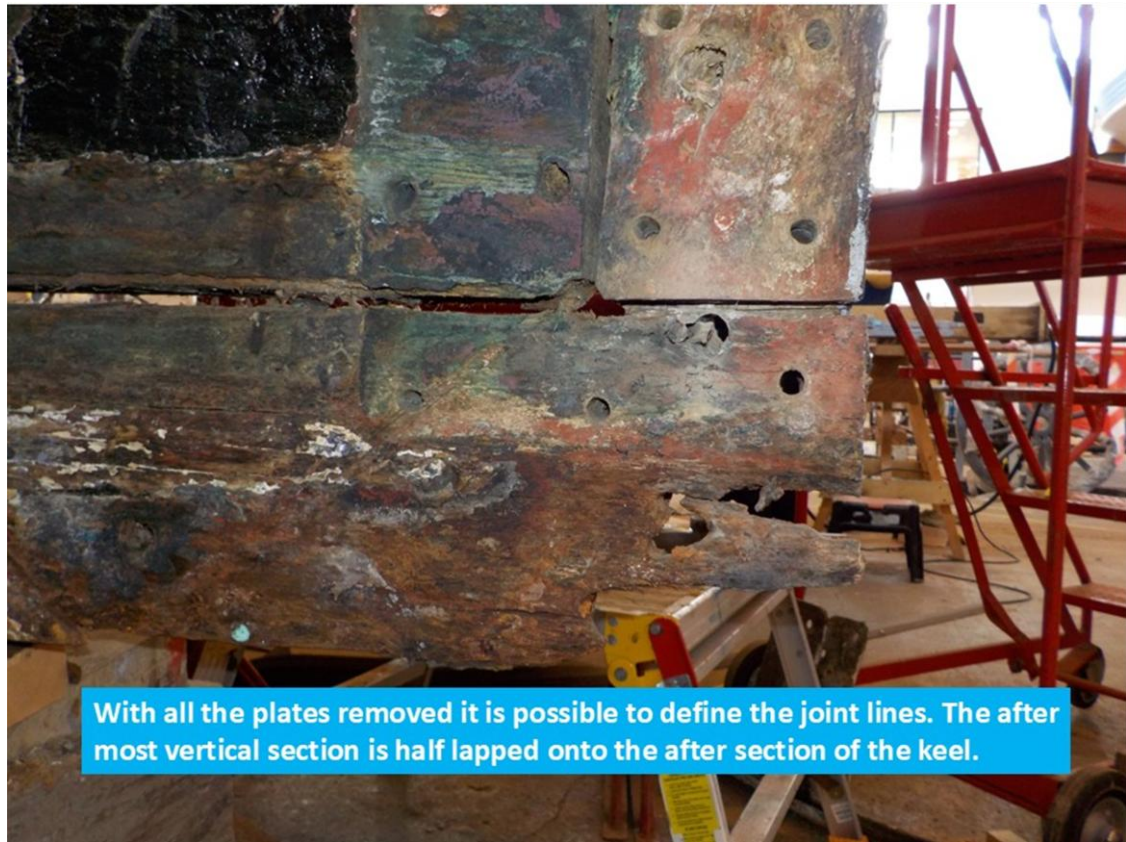
With all the plates removed it is possible to define the joint lines. The after most vertical section is half lapped onto the after section of the keel.

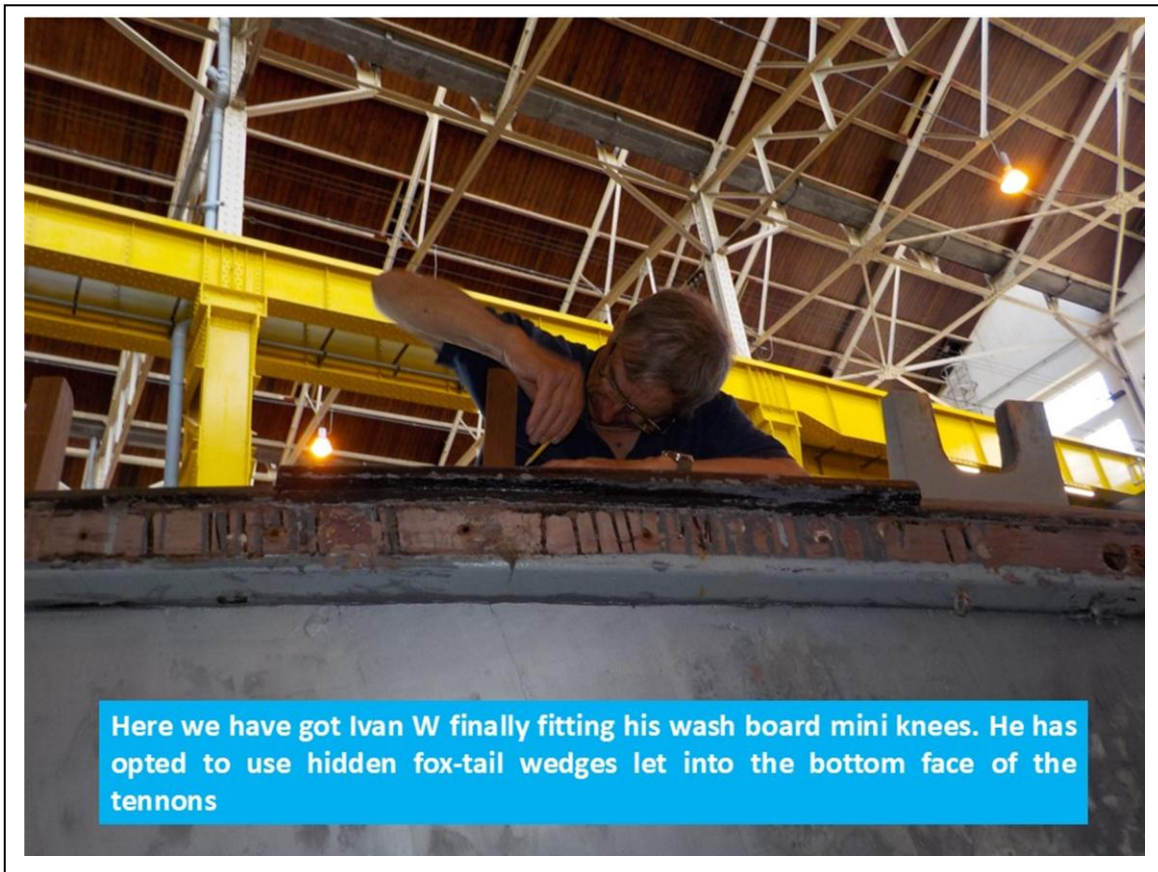
Here we have got Ivan W finally fitting his wash board mini knees. He has opted to use hidden fox-tail wedges let into the bottom face of the tennons

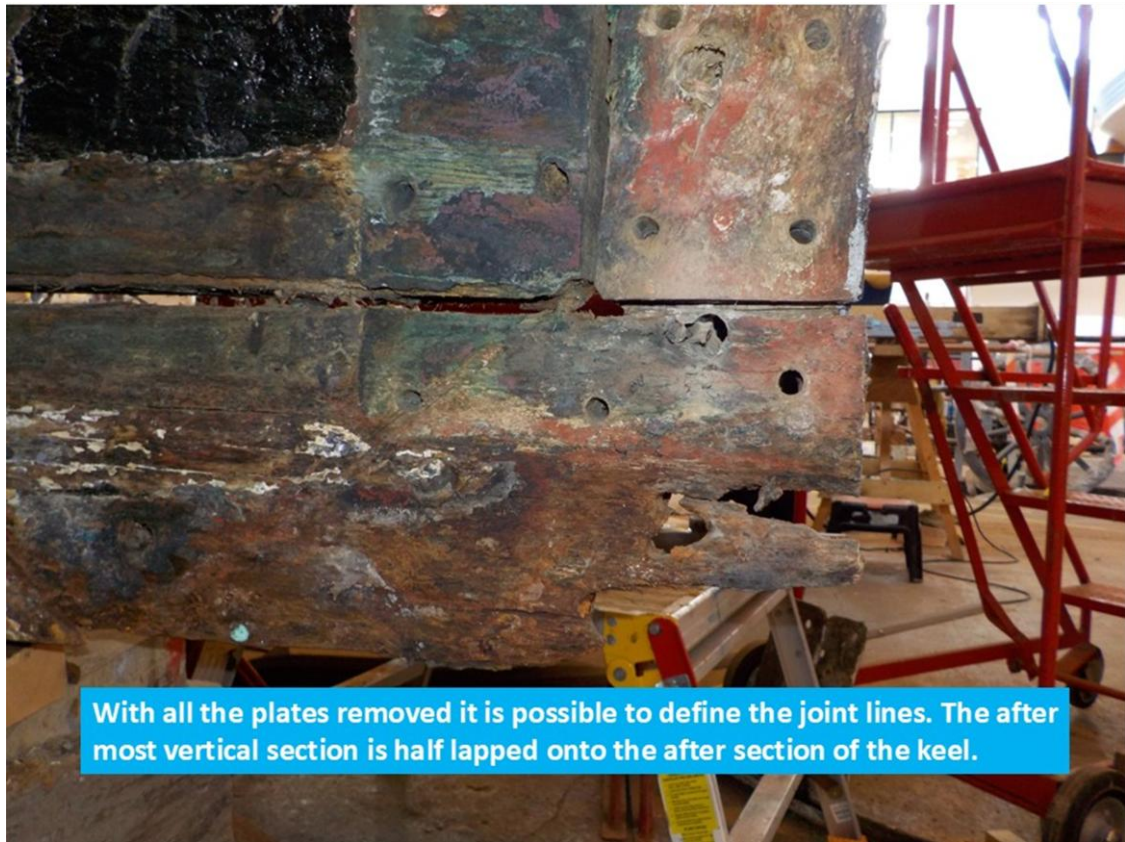
With all the plates removed it is possible to define the joint lines. The after most vertical section is half lapped onto the after section of the keel.

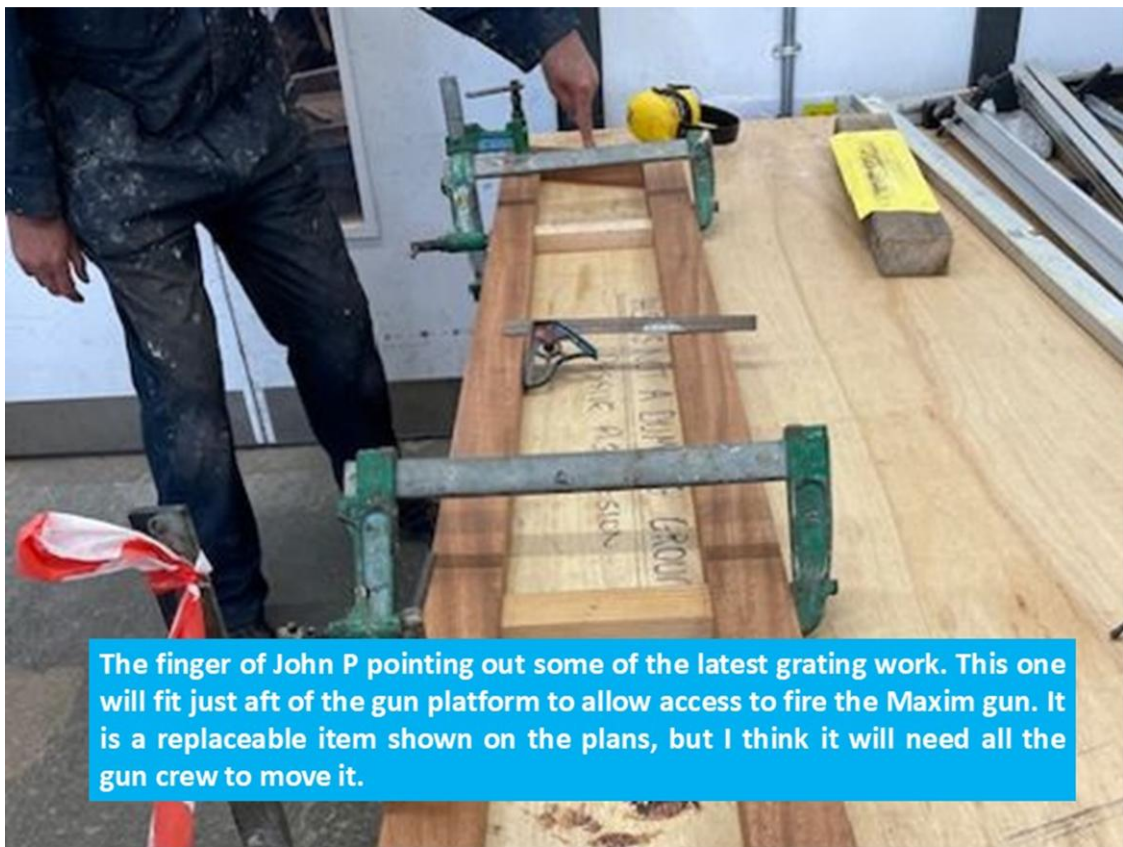
The finger of John P pointing out some of the latest grating work. This one will fit just aft of the gun platform to allow access to fire the Maxim gun. It is a replaceable item shown on the plans, but I think it will need all the gun crew to move it.

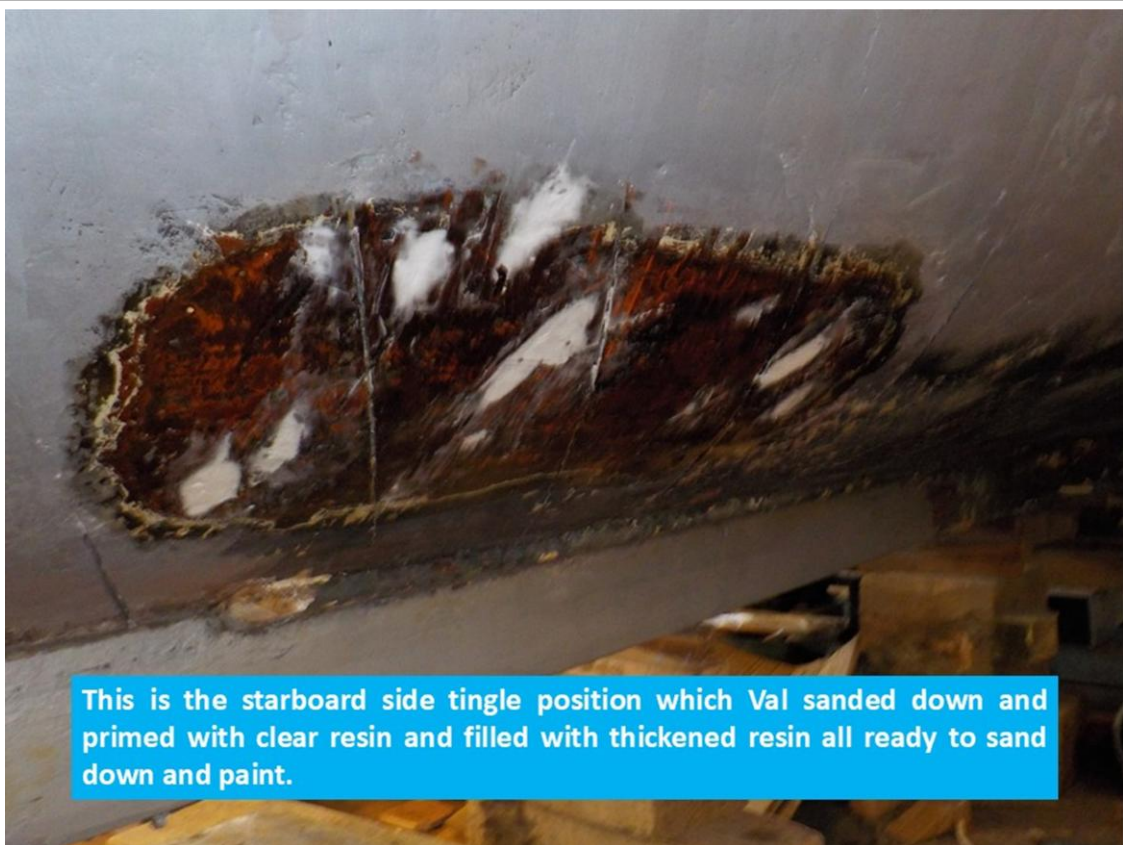
This is the starboard side tingle position which Val sanded down and primed with clear resin and filled with thickened resin all ready to sand down and paint.

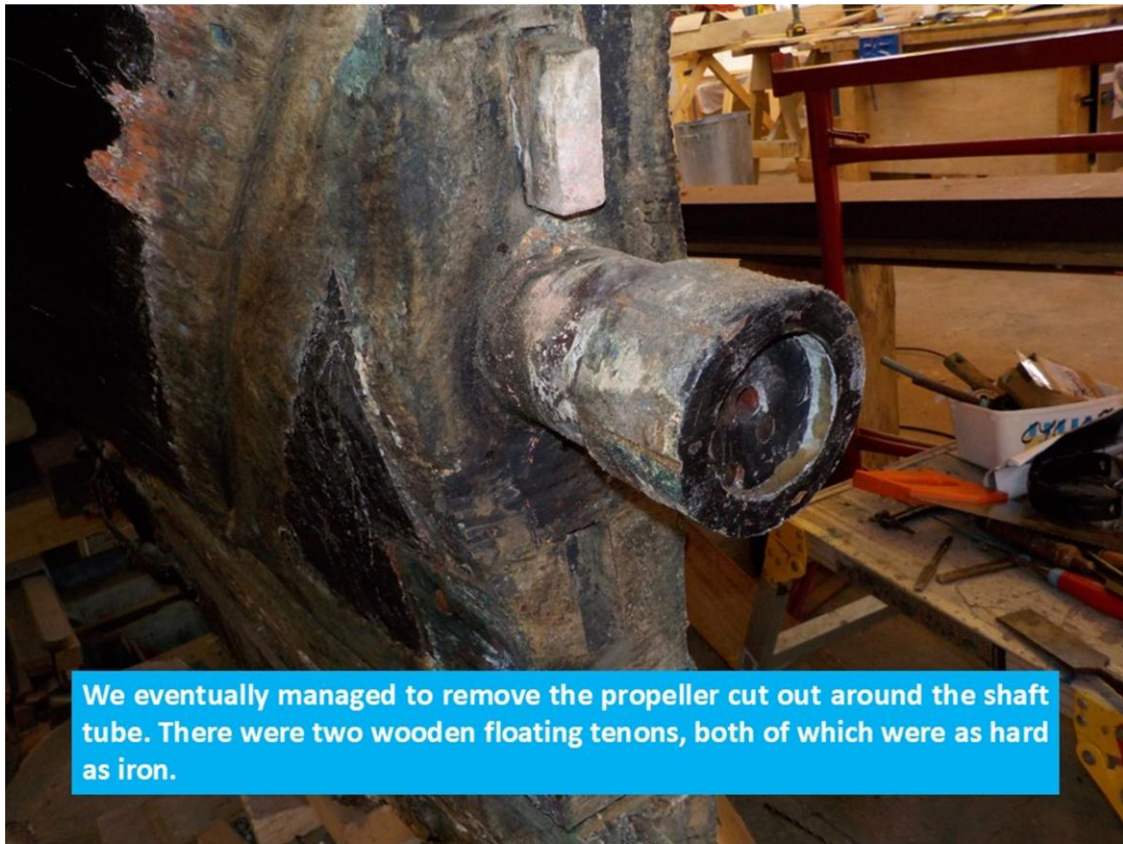
We eventually managed to remove the propeller cut out around the shaft tube. There were two wooden floating tenons, both of which were as hard as iron.

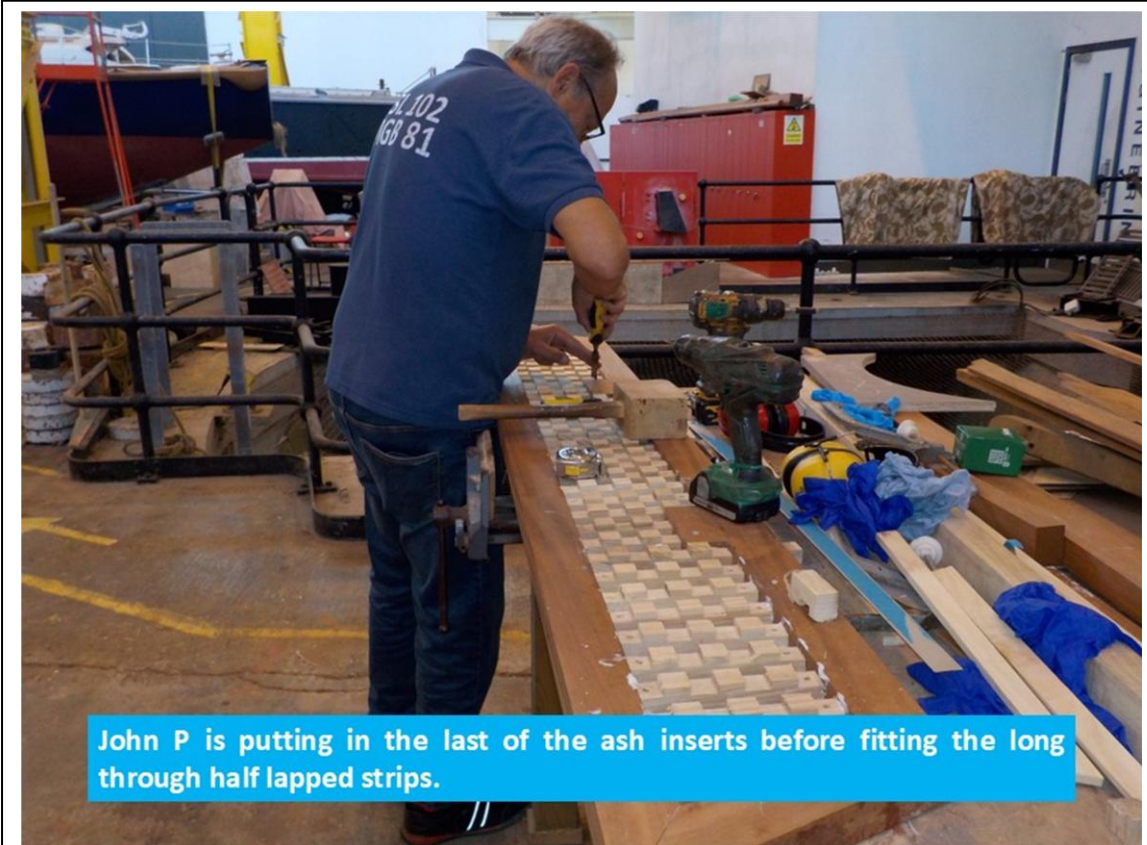
John P is putting in the last of the ash inserts before fitting the long through half lapped strips.

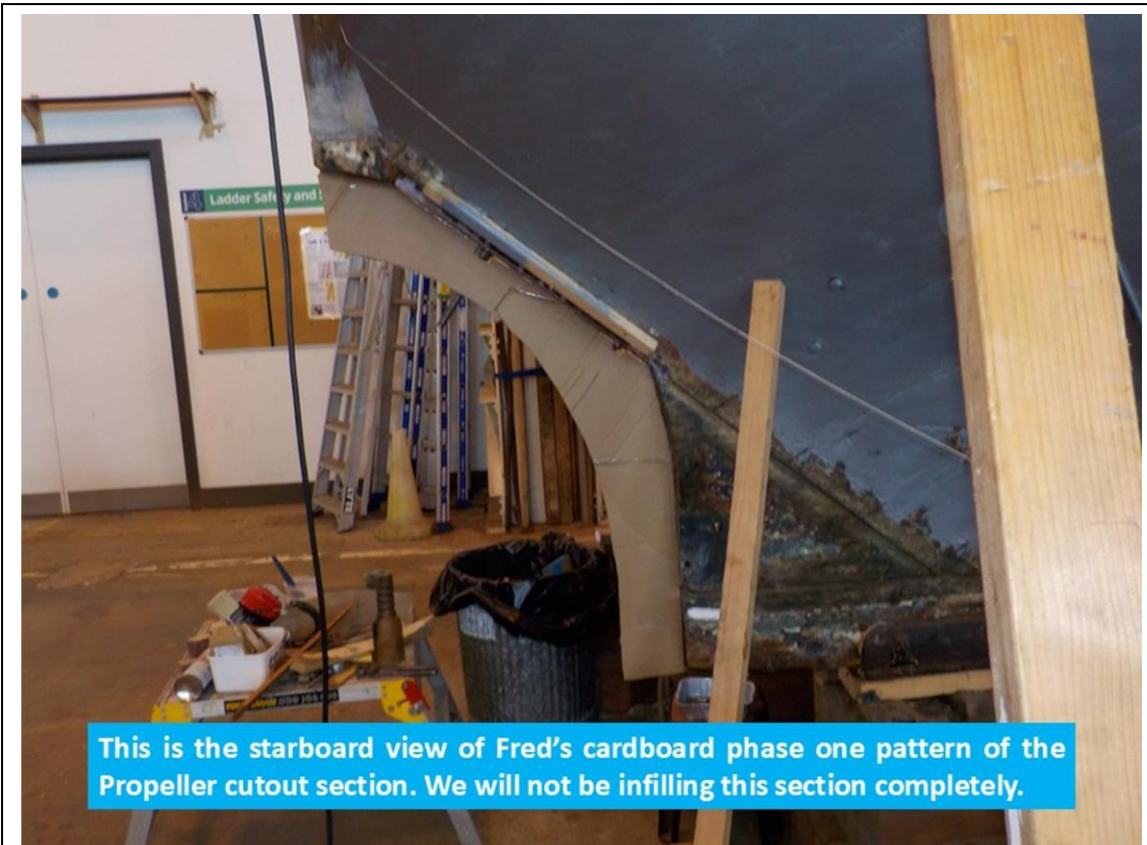
This is the starboard view of Fred's cardboard phase one pattern of the Propeller cutout section. We will not be infilling this section completely.
