Monthly News Letter

Boathouse 4/5 Volunteers

February 2018

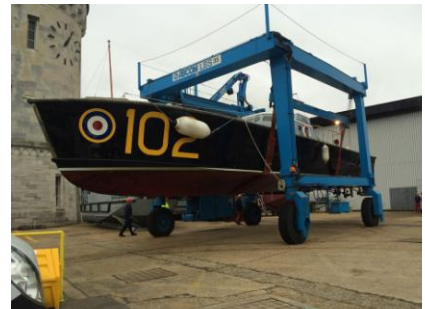
She is now back home following her mid winter refit and ever is looking stunning

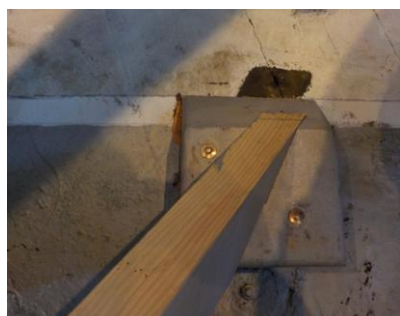
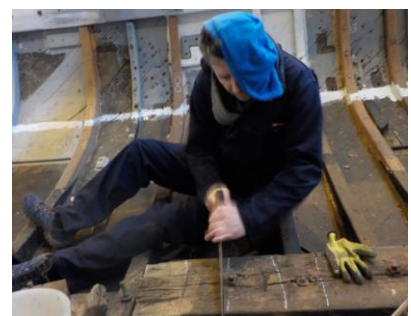
Cyclops Restoration Programme – As we said last month the sole bearers are now being fitted in the after section. John P and Keith D have been kept busy in the

month and as you can see from the photos above and over left there are lots of compound angles to be measured and cut, that will keep them out of

mischief for some time yet. Another of our long standing jobs is the fitting of a new keelson; this is a solid plank of timber 3inches thick and just short of 30feet long and sits over the frames bolted through to the hog. We cut the scarph in the new timber

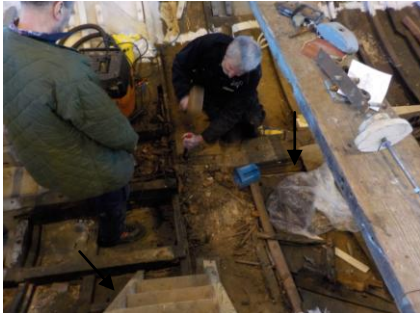
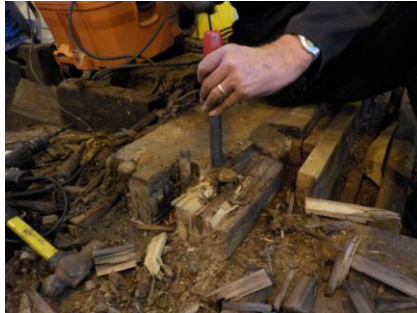
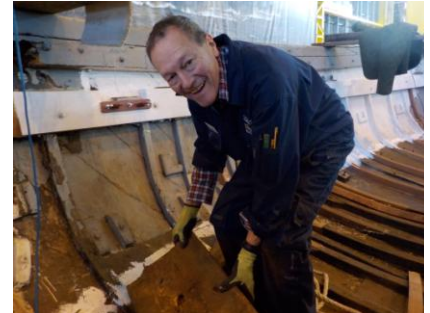
just before Christmas and they have been sitting awaiting completion of all of the through frames. Her old keelson needed to be removed so that job fell to several of the guys, the first section was actually removed by Geoff Griggs about 15 months ago. This time around we have had Gabi, David S, Keith D, John B, Chris H, Shiner W and David Y involved at various times hacking and hewing away to reduce the keelson down to lift able chunks that we could get out of the boat. In the photos above and over the page some of the process has been logged and recorded. Above right Gabi is cutting the keelson

through into short lengths that he can then split off the bolts. Below left David S and John B (who is obviously supervising the operation) are chopping out the second large cross section beam on which the 1980's Ferrari Hydraulic crane was fitted to. These were very solid sections of prime mahogany that had been quite well soaked in oil over the years so they weren't in a hurry to pop out. In the middle photo just to give you some idea of how they were taken out that is the Hand of David patiently chiselling around one of seven big bolts. Over right below Crafty John B has dived in to steal the glory as he plucks up the offending timber as soon as David had finished his bit.

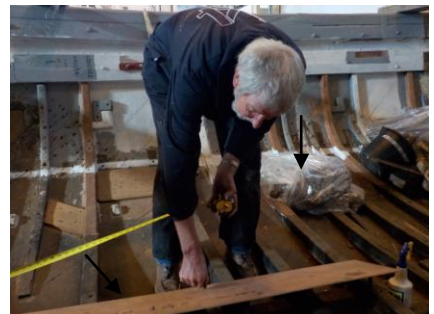
These baulks of timber weren't the only bits that needed removing from the bilges before we could get the keelson completely out, there was also quite a bit of concrete that had been put in over the years to stop the leaks, most of that was taken out as well.

Above left David S is swinging off the end of his hammer and bolster chisel as he cuts away the rotten concrete, whilst in the middle b above he has started to lay down the plywood pattern ready to mark and cut all of the bolt positions. We will use this later to transfer all of the hole positions onto our new keelson ready for drilling. Over right above he is doing his fine tuning before he 'hacks out the holes.

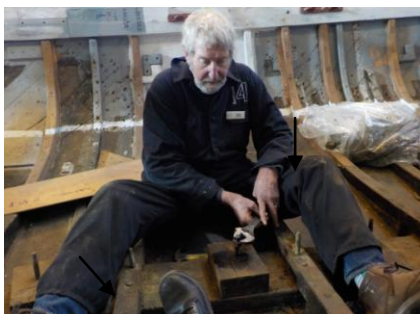
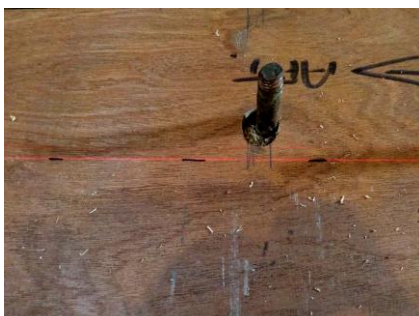
Before he could cut all of the holes and lay down the pattern David had to remove some very stubborn nuts, above left he looks suitably relaxed with a spanner on one of offending nuts. Middle photo above Brian D in true team work has picked up from David and is fine tuning the hole positions and setting up the centre line and datum marks. Over right above the near finished patterns are almost ready to be transferred to the new timber. In order to get some solid datum marks we used the laser level with which we have all fallen in love with but we did have to use the old fashioned tight string line and a plumb bob to locate the mid- point on the patterns first. If you look carefully at the photo over left you can just make out the red laser line over which we marked the black dotted line.

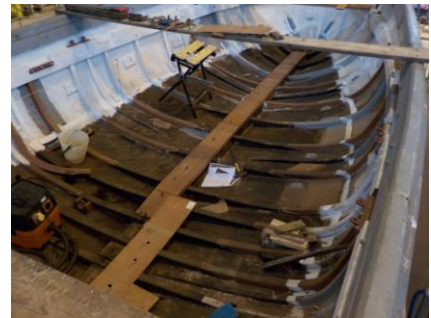
Finally the patterns were located onto the new prepared timber and tacked in place, this just left one final fine tune on the hole positions before the new keelson was drilled. On this section we had six centre line datum viewing holes and ended up with cross hair sightings for each bolt hole. When it is drilled if our calculations are right the new keelson will just slide over all of those bolts into position without any mallets, hammers or foul language. Watch this space but keep your fingers ready for your ears just in case Mr Cockup has joined the crew. Stop Press. Over right all worked out well with

the new forward section of the keelson in place as a dry fit.

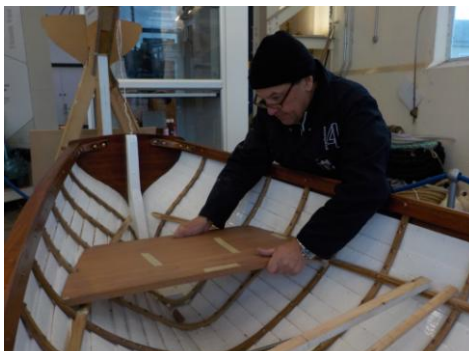
Dartmouth Gig Restoration- The transom fittings are going on with the upper pintle in place so that

shortly the rudder can be hung, the stern seat has been beautifully fitted by Alessio as has the capping strips. Geoff G has made a set of thwart

stanchions and all of the thwarts have been trial fitted. Over right above the new rudder that Tom has made can be seen along with over left the tiddly thwarts and knees are getting finalised

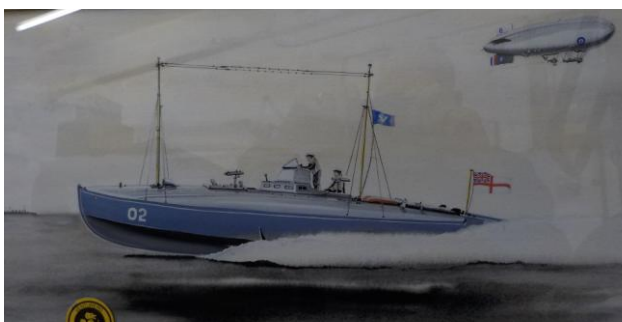
New Build CMB4 – The picture below is of CMB2 I have included it here purely as being representative

of CMB4 to give everyone some idea of the beast that we have undertaken to replicate. Last month we took delivery of some of her timber and this month we have laid out the lofting floor. Over

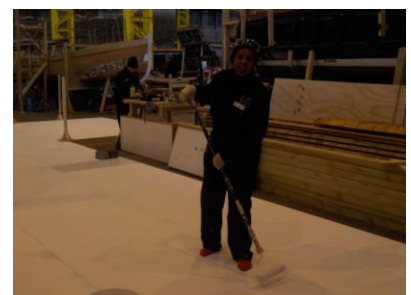
right Fay is busy painting the new lofting floor with strict instructions to all users to take off their shoes and boots before venturing onto the floor. On the next page you can see John W and David G making a start to lay off the lines. The section they are doing here is that of the body plan from which we will eventually make the building moulds for the boat.

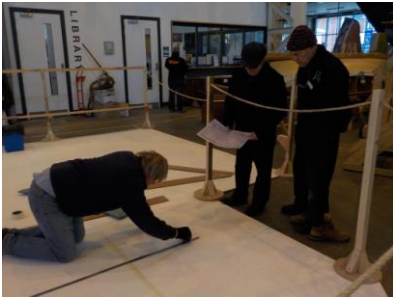
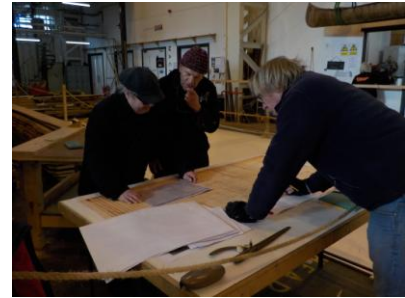
Above left David G is marking a point on the having taken the reference from the scale plans, centre above he is plotting further points and over right Bob F, John W and David are having deep and meaningful discussion about the finer points of lofting. These initial forays into lofting are part of an overall training exercise so that everyone can find their way around the various lines drawings and tables of offsets. Once everyone is happy then pins will be nailed into the lines and fairing battens taken round and the fair lines will be drawn solidly. It is from these final lines that the moulds will be

made. The lofting floor is really a full sized set of drawings that that have been extrapolated from the scale drawings and proved with fairing battens. In the photo above left the Body Plan is shown, please note that this is a photo of a copy of the original 1916 drawings and the 'Confidential' status is applicable to that year.
